**Flood Control Project Maintenance
Levee Inspections****LMA District Cover Sheet
Spring 2015 Levee Inspection Results****Reclamation District No. 1601 Twitchell**

Levee Inspection Report By Mile - Spring 2015

Waterway	Bank	Unit Miles	Inspection Start/End	Inspector
Unit No. 01 Threemile Slough	Left	2.43	04/08/2015 04/08/2015	Richard Willoughby

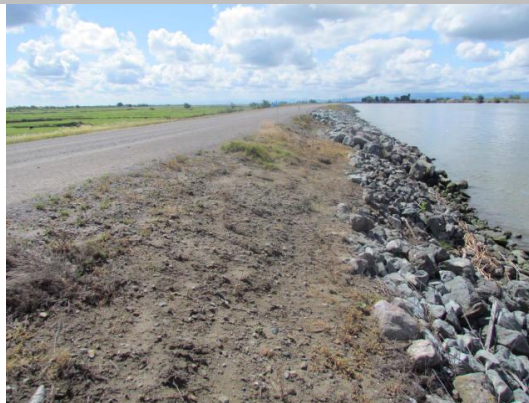
Photo 1 of 2 : SP_2015_RD1601_237_15_20150409_00005.jpg

LM Start	1.27	Rating **	M	Issue No.	15
LM End	1.28	Issue Type +	Ma	Location *	WS
Category	Earthen Levee			GPS Latitude/Longitude	
				Start	End
Item	Slope Stability			38.104340 °	38.104114 °
				-121.683890 °	-121.683933 °
DWR ID	DWR_RD1601_01_s _ 2015_15				
Action/Comments					
Repair slope instability. Inspector Comments: Slight caving observed on waterward shoulder and slope.

Looking south at depression/caving on waterward shoulder and slope.

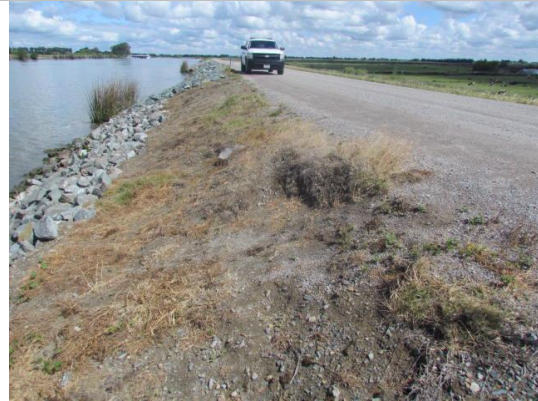
Photo 2 of 2 : SP_2015_RD1601_237_15_20150409_00006.jpg

LM Start	1.27	Rating **	M	Issue No.	15 (cont)
LM End	1.28	Issue Type +	Ma	Location *	WS
Category	Earthen Levee			GPS Latitude/Longitude	
				Start	End
Item	Slope Stability			38.104340 °	38.104114 °
				-121.683890 °	-121.683933 °
DWR ID	DWR_RD1601_01_s_2015_15				
Action/Comments					
Repair slope instability. Inspector Comments: Slight caving observed on waterward shoulder and slope.

Looking north at depression/caving on waterward shoulder and slope.
